Home Inspection Report

?? Tremont Ave, Westfield , NJ 07090

Tuesday March 31, 2015

Cornerstone Home Inspection
9736504151

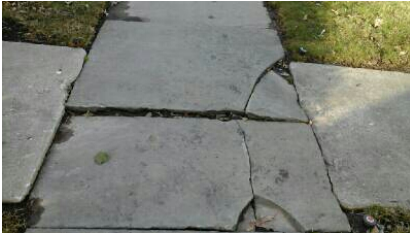
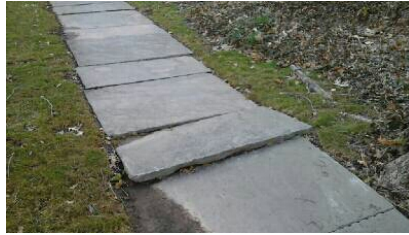
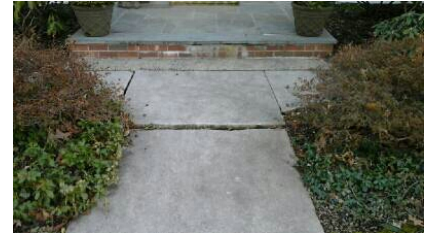
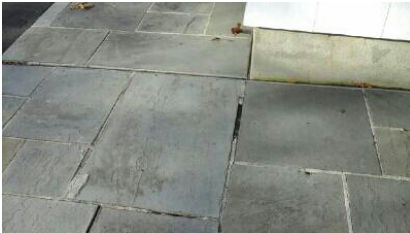
Comments **Service Walks :**
The town walkway has uneven surfaces. The concrete walkway to the home had cracks and uneven surfaces. Both areas have trip hazards. The rear bluestone walk had loose mortar. Recommend a mason examine and repair all these areas as needed.

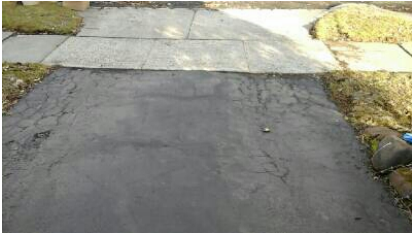
Comments **Driveway / Parking:**
The driveway has settled near the street and has cracks in various areas. Recommend repair and sealing.

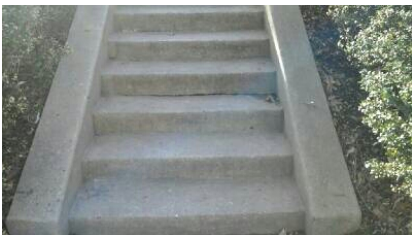
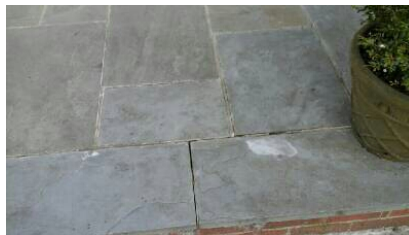
Comments **Stoop/Steps:**
Recommend railing for steps from the sidewalk. Front step landing has loose mortar needing repair.

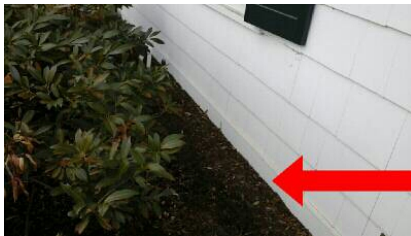
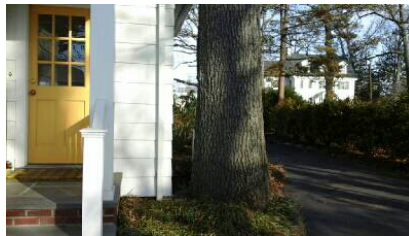
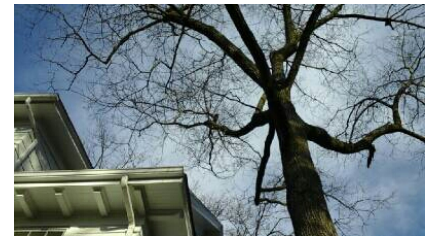
Wood to soil contact

Comments **Landscaping:**
 There is wood to soil contact all along the front of the home. This can cause wood rot and promotes insect activity. Recommend a landscaper correct this issue. The tree near the rear corner of the home should be removed.
 Recommend window well covers.

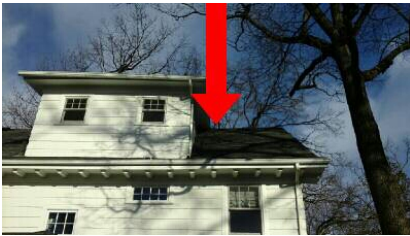
The roof covering is older and in satisfactory condition but the rear roof structure had settled to the right side of the rear dormer. Recommend a structural engineer evaluate.

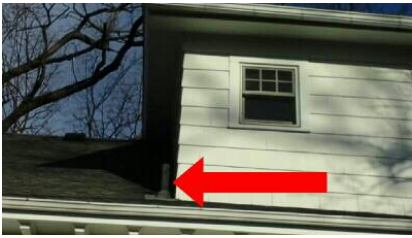
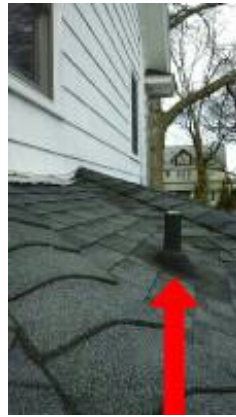
Comments Plumbing Vents: Three of the rear plumbing vents on the rear of the home are within 10' of a window. Recommend a plumber and roofer evaluate and correct as needed.

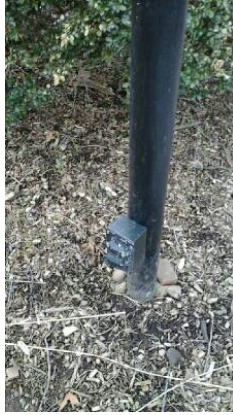
lamp post outlet

Comments cont. Recommend GFCI protection for all exterior outlets. Needed on the front lamp post outlet. The exterior rear outlets did not function. Recommend electrician correct.

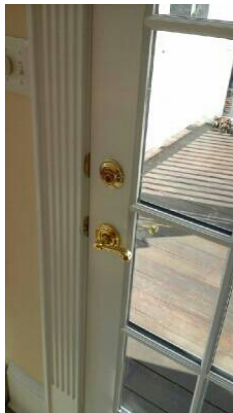
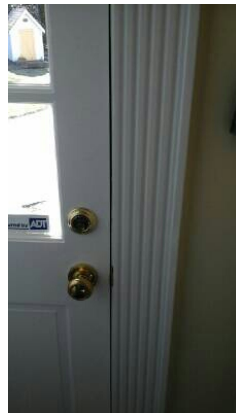
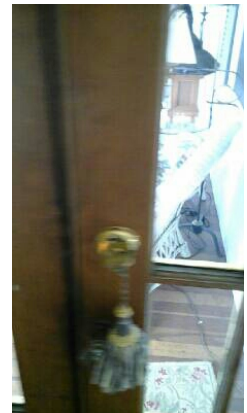
Keyed egress door locks should be changed to quick throw dead bolts. Fire safety concern. The front door frame is pushed out at the floor.

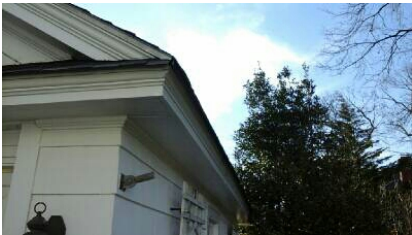
Comments **Garage Gutters:** Recommend installing gutters and/or downspouts.

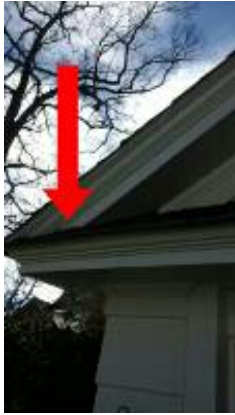
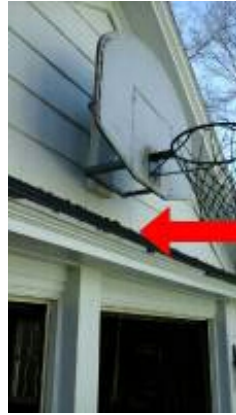
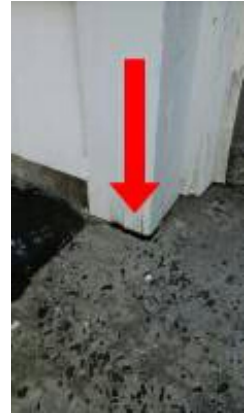
Comments **Garage Siding/Trim :**
Siding and trim have some damage recommend repair.

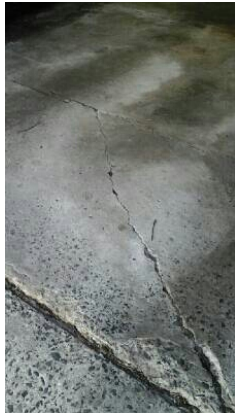
Material ☒ Concrete
Condition ☒ Recommend evaluation/repair
Source of Ignition within 18" of the floor ☒ N/A
Comments **Garage Floor:**
 Garage floor has large settling cracks recommend repair.

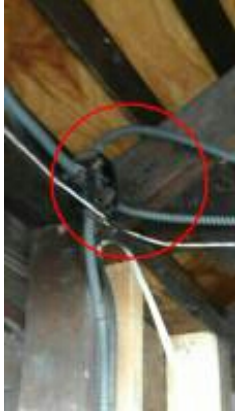
Comments **Garage and Exterior Electrical:**
Extension cord wiring, recommend dedicated outlet(s) be added.
Recommend confers for junction boxes.
Recommend GFCI protection for garage outlets.

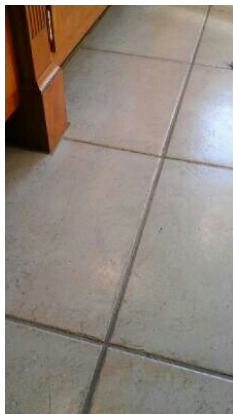
Comments **Kitchen Floor Covering:** The floor tiles are hollow sounding cracked and loose. Recommend tile contractor examine and repair as needed.

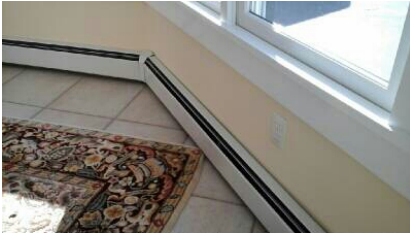
The electric outlets on the diningr area did not operate. Recommend electrician correct . This may be related to the exterior outlets that did not function.

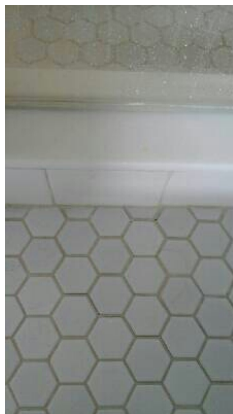
Comments **3rd Floor Bath:**
Recommend caulking the floor near the shower. The room door will not close. Drags on saddle.
Recommend repair. Window frame is slanted due to settlement described on roof section.

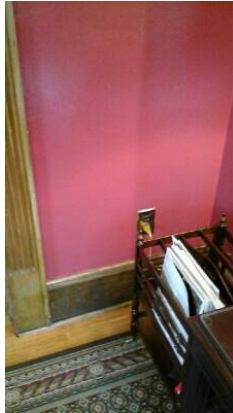
Comments **Family Room** : The outlet to the right of the room door is wired in reverse polarity. Recommend electrician correct.

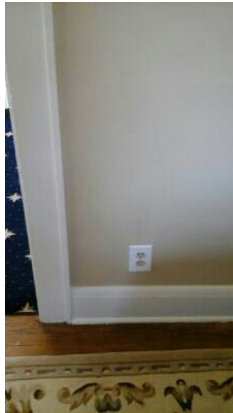
Comments **2nd Bedroom:**
The outlet to the right of the room door is unground. Recommend electrician correct.

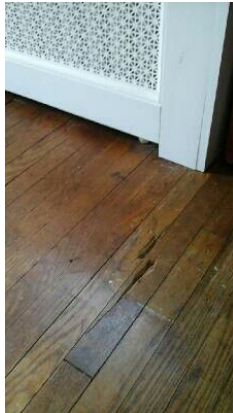
Comments **3rd Bedroom:**
The room door will not latch. The floor has damage that may cause injury. Recommend repair.

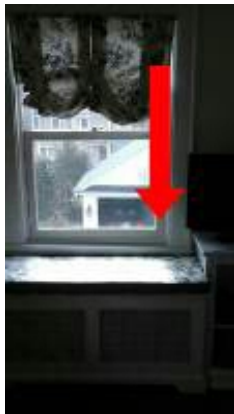
Comments **4th Bedroom:**
The roof sag described outside the home shows indications inside this room. ..window is level. Frame is not.
For slopes as a result.

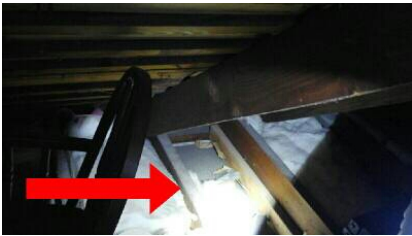
Missing insulation

Comments **Attic/Structure/Framing/Insulation:**
Insulation is missing on the area off the cost of bedroom 5. Recommend installing insulation.

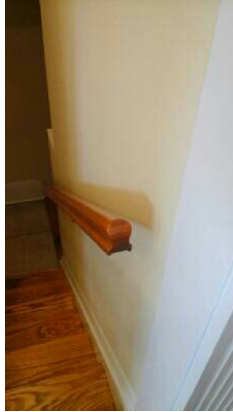
Comments **Basement Stairs:** The handrail ends should curve into the wall so not too catch clothing or body parts.

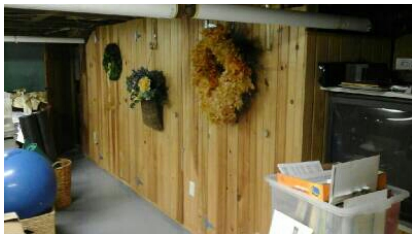
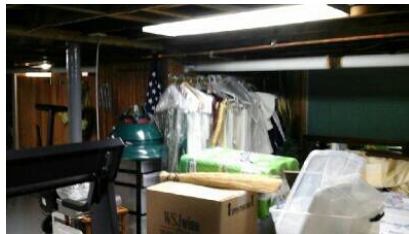
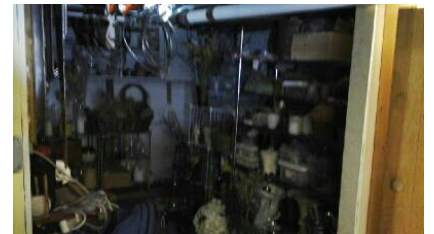
Comments **Foundation:**
Foundation walls were covered with storage material and were not visible. Cluttered conditions
Foundation walls were covered with paneling/drywall and were not visible.
Recommend an evaluation when emptied.

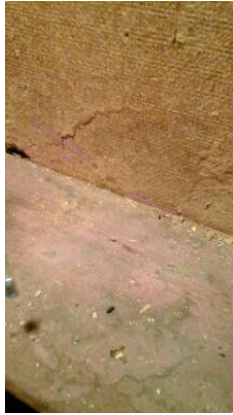
Comments **Basement Floor:** There are mouse droppings in many areas of the basement. Recommend extermination company examine evaluate and correct this issue.

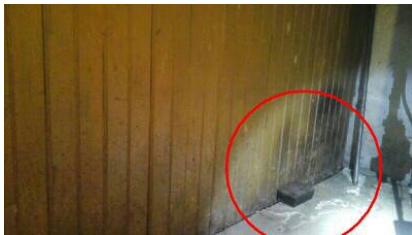
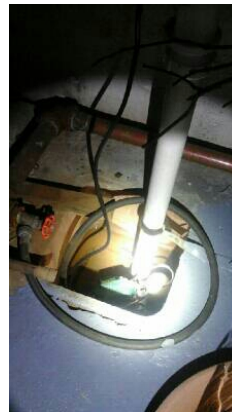
Although there is no current indication of water entry but past entry obvious, it is recommended the exterior grade be sloped away from the home and gutters kept clean. If a sump pump is present, it should be tested periodically making sure it operates. The sump pump pit is undersized. Recommend a larger pit.

Recommend consulting with a waterproofing company.

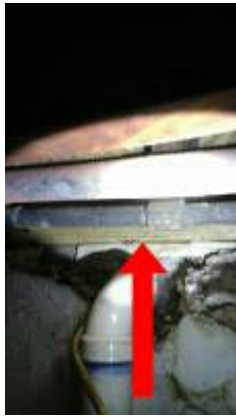
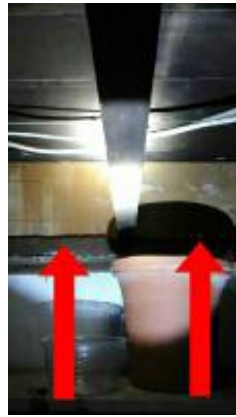
Extensive repairs have been performed but it is unable to be evaluated due to clutter and materials.

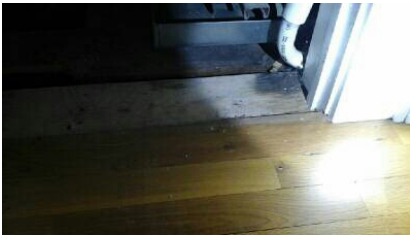
A/C was not operated due to outside temperature. It appears the condensate line has leaked in the past (OFF CLOSET OF BEDROOM 5). Recommend Technician examine and correct if needed. The stain may contain mold. Recommend testing and remediation depending on results.

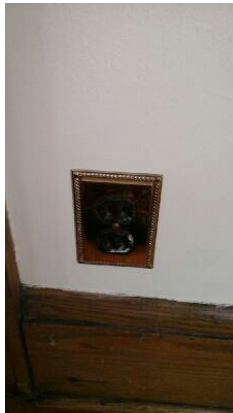
2 prong outlets

There are 2 prong electric present should be changed to 3 prong grounded outlets. There is old knob and tube wiring present near the closet for the main panel that may indicate is presence in other areas. This wiring was not live but would be properly terminated and removed if in other areas. There is open wiring in this same closet that should be terminated. Branch wires under sized on the bottom left 2 breakers. Recommend licensed electrician repair and/or replace as necessary. Open junction box above the dryer needs cover.

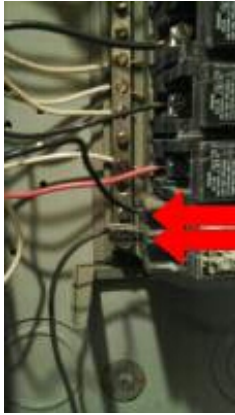
undersized wires

Branch wires under sized on the bottom left 2 breakers. Recommend licensed electrician repair and/or replace as necessary. Open junction box above the dryer needs cover.
