Inspection Report

Inspector: Michael G Dominianni

**Inspection Address:
10 West Road Caldwell NJ 07006**

**Inspection Prepared For:
Kimberly & Gary
Date of Inspection: 7/23/2022**

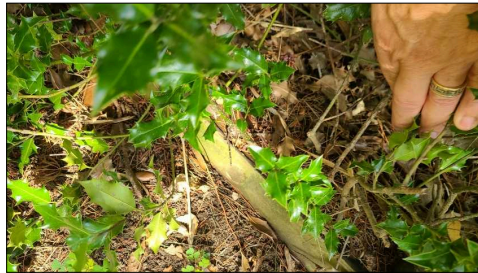
- The railroad tie retaining walls around the front planting beds are badly rotted and damaged from carpenter ant activity. Recommend contractor examine, replace and treat for carpenter ant activity.

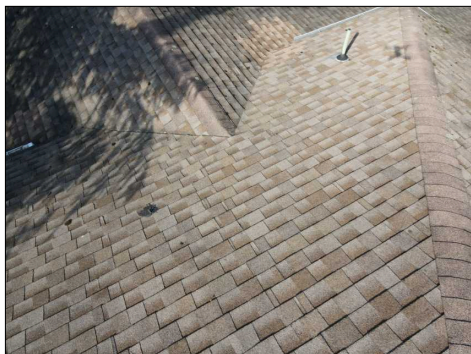
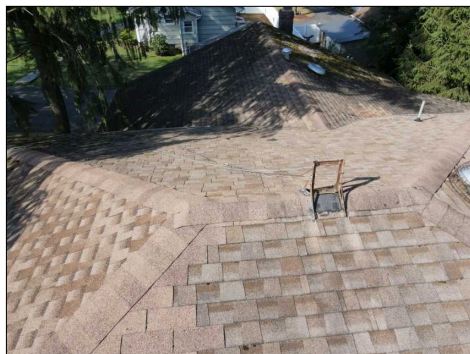
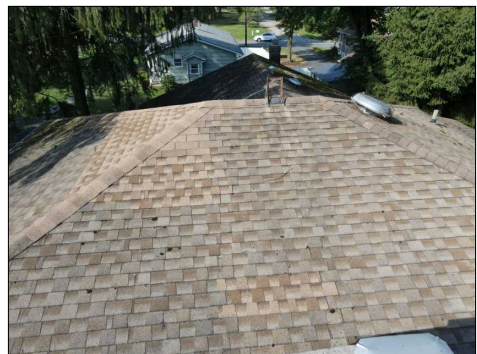
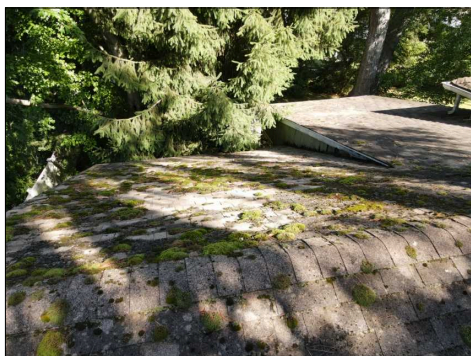
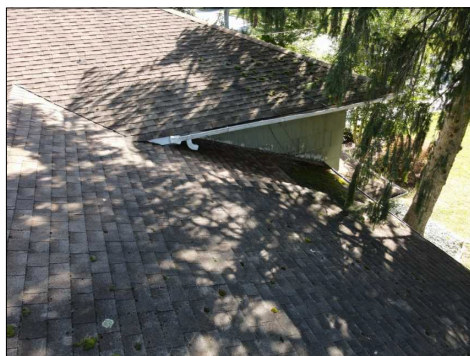
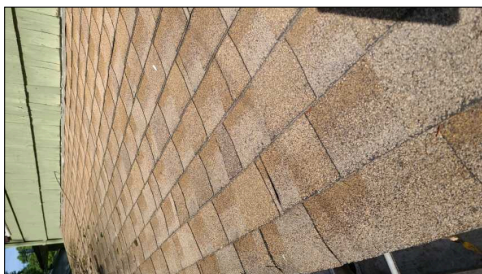
6. Condition of Roof Covering

- Granules missing
- Moss buildup
- Recommend roofer evaluate

• There is a bracket on the peak of the upper roof that should be removed and any holes from screws or nails repaired. There is a large degree of moss build up as well as some damaged shingles throughout. There are possible leaks in the roofing material visible from the attic where stains are present in the Attic and on the ceilings in the family room and garage. Recommend roofing contractor examine and repair as needed. Check with local building authorities regarding age and permits for this roof installation. Budget for roof replacement and the not too distant future.

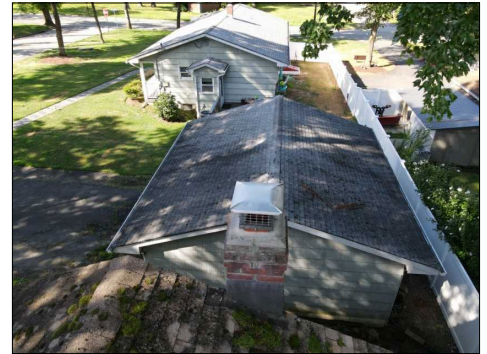
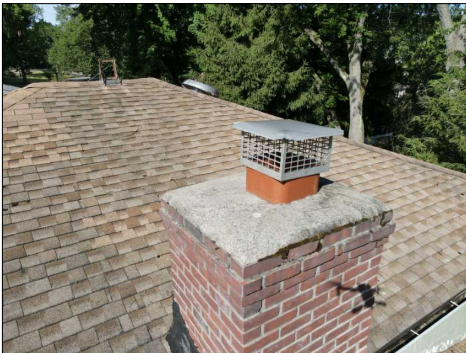
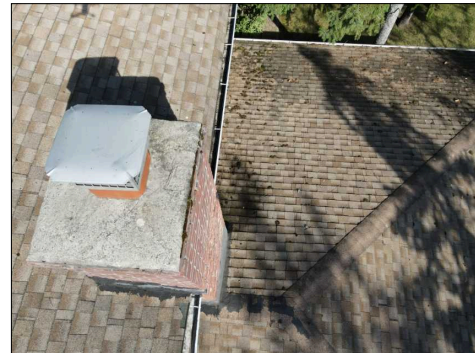
• The furnace chimney on the south side of the home appears to be pulling away from the house. This can cause internal chimney damage and may indicate chimney foundation failure. Recommend a chimney Mason evaluate, repair or replace as needed. Both chimneys appear to have cracks around the masonry cap. Recommend a chimney Mason evaluate and repair as needed. The fireplace chimney has been evaluated during a level 2 inspection. Refer to that report.

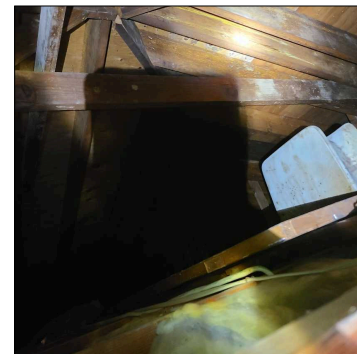
- The evaluation of the attic over the garage is very limited because of the amount of storage in the garage made it difficult and impossible to actually gain access into the attic. Pictures were taken from the attic opening only.
- Recommend another inspection when the area is clear and able to be accessed.
