Inspection Report

Inspector: Michael G Dominianni

**Inspection Address:
10 West Road Caldwell NJ 07006**

**Inspection Prepared For:
Kimberly & Gary
Date of Inspection: 7/23/2022**

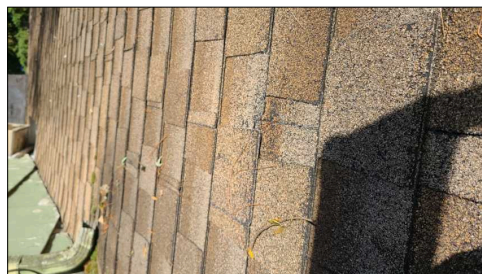
• There is a bracket on the peak of the upper roof that should be removed and any holes from screws or nails repaired. There is a large degree of moss build up as well as some damaged shingles throughout. There are possible leaks in the roofing material visible from the attic where stains are present in the Attic and on the ceilings in the family room and garage. Recommend roofing contractor examine and repair as needed. Check with local building authorities regarding age and permits for this roof installation. Budget for roof replacement and the not too distant future.
